## SCRUTINY CALL - IN REQUEST FORM

Title.....Shearwater Trees.....

**Our ref 9696: Boundary Wall to the Rear of 12 Shearwater Close**

**TECHNICAL SPECIFICATION  
FOR  
BRICKWORK WALL REMEDIATION WORKS  
HARTSHOLME COUNTRY PARK  
AND  
PROPERTIES ON SHEARWATER CLOSE  
LINCOLN**

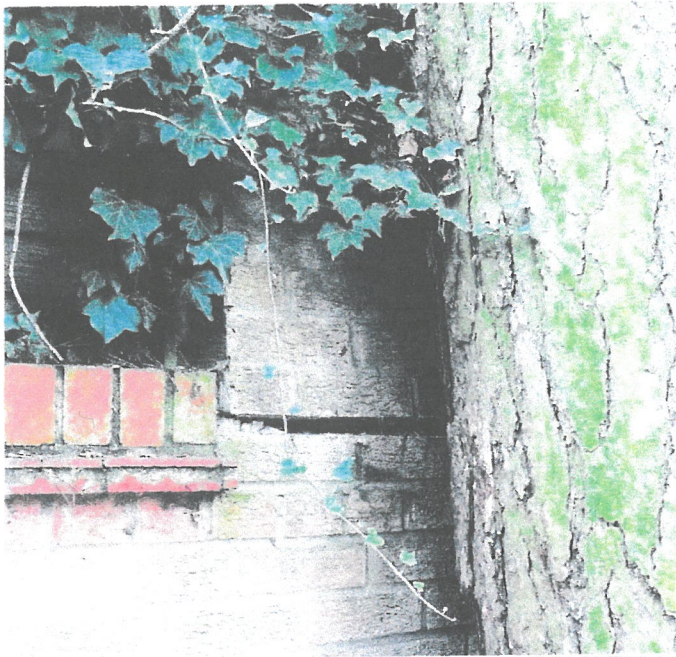
scheme that was proposed by Ward Cole did not address the fact that the trees at the time were in contact with the wall and specifically the parapets that were fractured horizontally by the direct contact of the trees were not reinforced. Therefore, inevitably, further damage has occurred to the wall leaving the parapet, where trees are in contact with the wall, in a dangerous condition. I enclose a photograph of the parapet location and note that the

10mm crack has occurred in the time since repairs were undertaken in 2011. Furthermore, at lower level horizontal fracturing has appeared on the line of a repaired fracture. It is apparent that this damage is neither controlled or contained by the repairs undertaken in 2011. The scheme devised by Ward Cole at this time was, therefore, ineffective as implied by the statement from Jeremy Stanton quoted above implies.

Your neighbours, at the time, Dr and Mrs Emara, were also in dispute with Lincoln City and we advised them, as we had you, that the only effective method of dealing with the damage was to rebuild the wall on piles and isolated foundations, accommodation the roots and providing a sufficient distance between the wall and the trees to allow for future growth and movement. This scheme was adopted by Lincoln City Council for Dr Emara's property, and the scheme has been effective as no damage is apparent. This scheme was undertaken in 2002, and Ward Cole drew up the scheme that was subsequently constructed.
