## SCRUTINY CALL - IN REQUEST FORM

Title.....Shearwater Trees.....

**Our ref 9696: Boundary Wall to the Rear of 12 Shearwater Close**

**TECHNICAL SPECIFICATION  
FOR  
BRICKWORK WALL REMEDIATION WORKS  
HARTSHOLME COUNTRY PARK  
AND  
PROPERTIES ON SHEARWATER CLOSE  
LINCOLN**

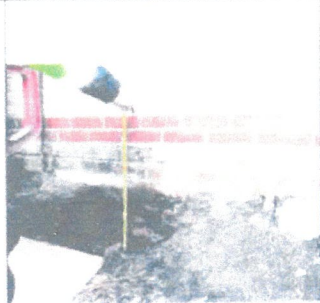
| WORK ITEM | DESCRIPTION | Drawing Ref<br>18018/--- | Spec'n Ref | Photograph |
|--|---|---|---|---|
| <u>Trial Holes</u> | <p>Excavate trial holes against the wall to expose the existing foundation and check adequacy.</p> <p>Trial holes to be taken to a depth just below existing foundation level.</p> <p>Trial holes will be inspected by Blue Sky prior to backfilling</p> | 101 | - | |
