### **PLANNING COMMITTEE**

### **2 DECEMBER 2020**

SUBJECT: WEST COMMON NEW LAND DRAIN

WEST PARADE ENTRANCE

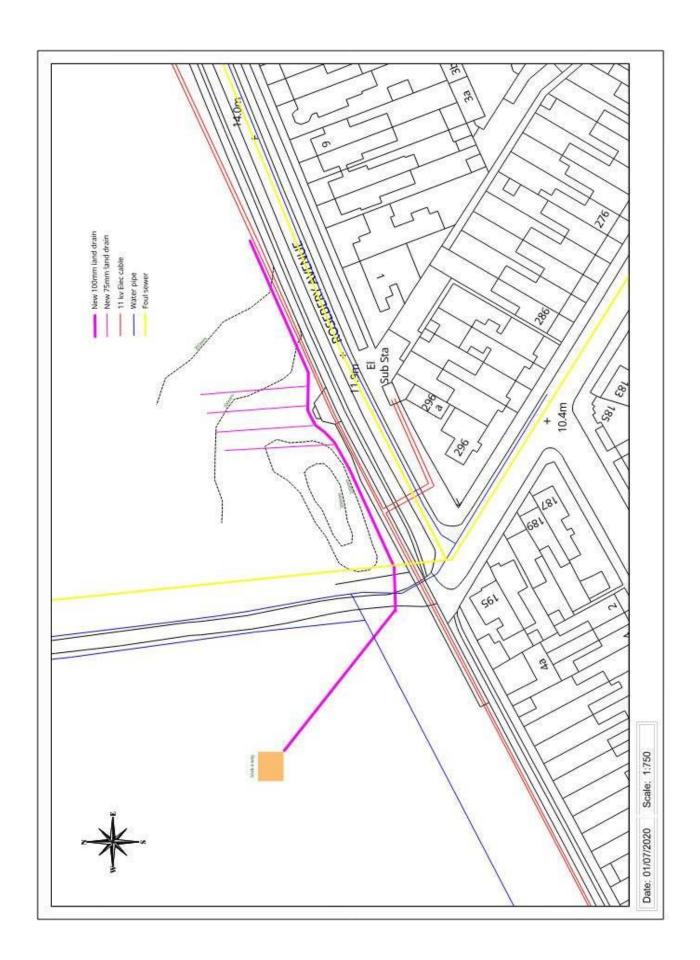
- 4.2 This system would consist of a 100mm main drain (approx.124m), laid along the boundary fence of the common, running under the tarmac footpath, then out to a rougher area of grass away from any paths and into a soak-away. From this main drain 75mm laterals will run out in front of the feeding area, four at approx.20m (80m total).

- 4.3 The drains will be excavated to a depth of 700-800mm, perforated drainage pipe laid in the bottom, back filled to the surface with clean pea gravel and then topped-off with sharp sand.

- 4.1 The best way to try and remove the water from the surface of this part of the common is to install a new land drainage system in the area. See Appendix 2.

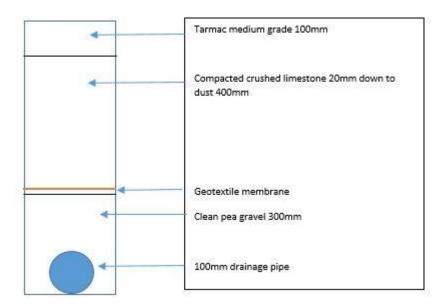
# Appendix 4

- 4.6 Where the main drain runs under the tarmac path and excavation works are carried out pedestrian access must be kept open, so the area will need signing and guarding to allow for foot, bicycle, wheelchair and pushchair access. Depending on the ground condition a temporary surface may have to be laid. On completion of this excavation this section of drain will be backfilled as Appendix 4 and the tarmac repair will be compacted to the existing levels of the surrounding path.
